Voluntary Cleanup Plan – Closure Report

Loomis Chevron Site
18 Palmer Ave, Loomis
Okanogan County, Washington

Don Phelps, PE, D.WRE
Water Resources Engineering
PO Box 159
Chelan WA 98816
509-888-0461

7/23/2009

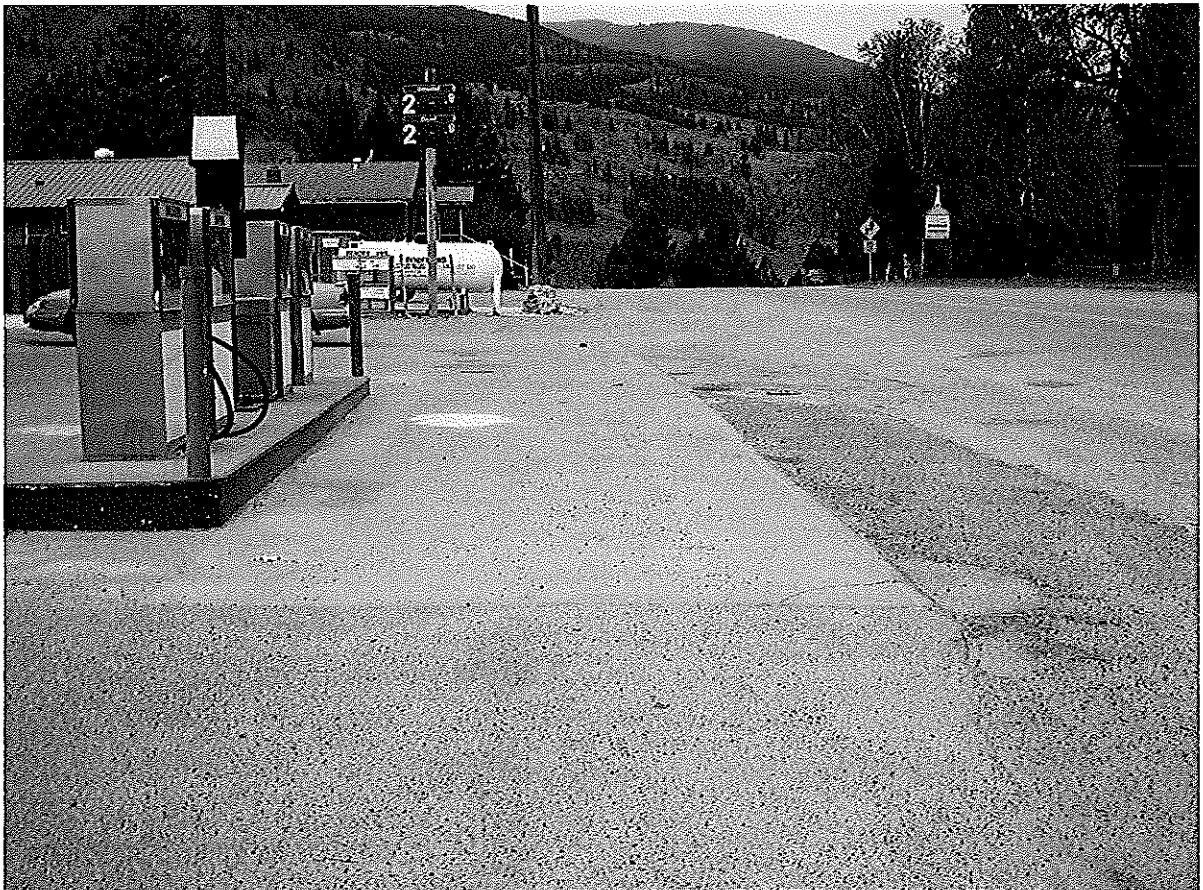
Figure 1 Looking west showing the concrete driveway extending to the edge of the right of way and asphalt from there to the center of Palmer Ave. There is a significant grade break at the highway caution sign with the terrain dropping 100 feet down to the valley floor. The interface between the asphalt and the concrete makes a very shallow drainage swale draining to the east on Palmer Ave. During winter months snow is stockpiled to the right of the propane tank on the shoulder of the road with subsequent melt flowing to the east. Palmer Ave. has a 2-3 percent grade at this point.

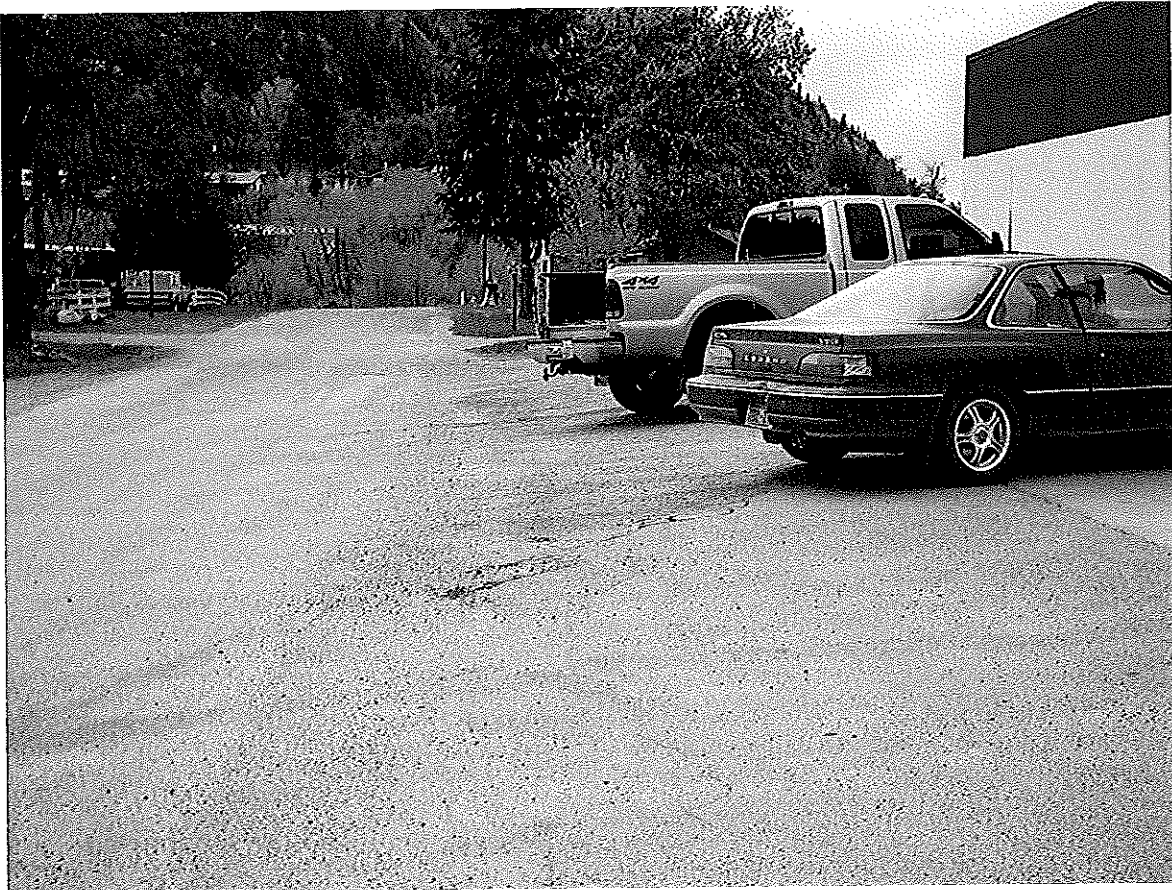
Figure 2 Looking south from the north east corner of the subject property. There is a concrete apron extending out from the building about 10 feet and then dropping a couple of feet to the street grade. During the winter months snow is plowed to the south and stockpiled in the grassy area just showing behind the pickup. Any subsequent runoff from snowmelt runs southerly along the street.

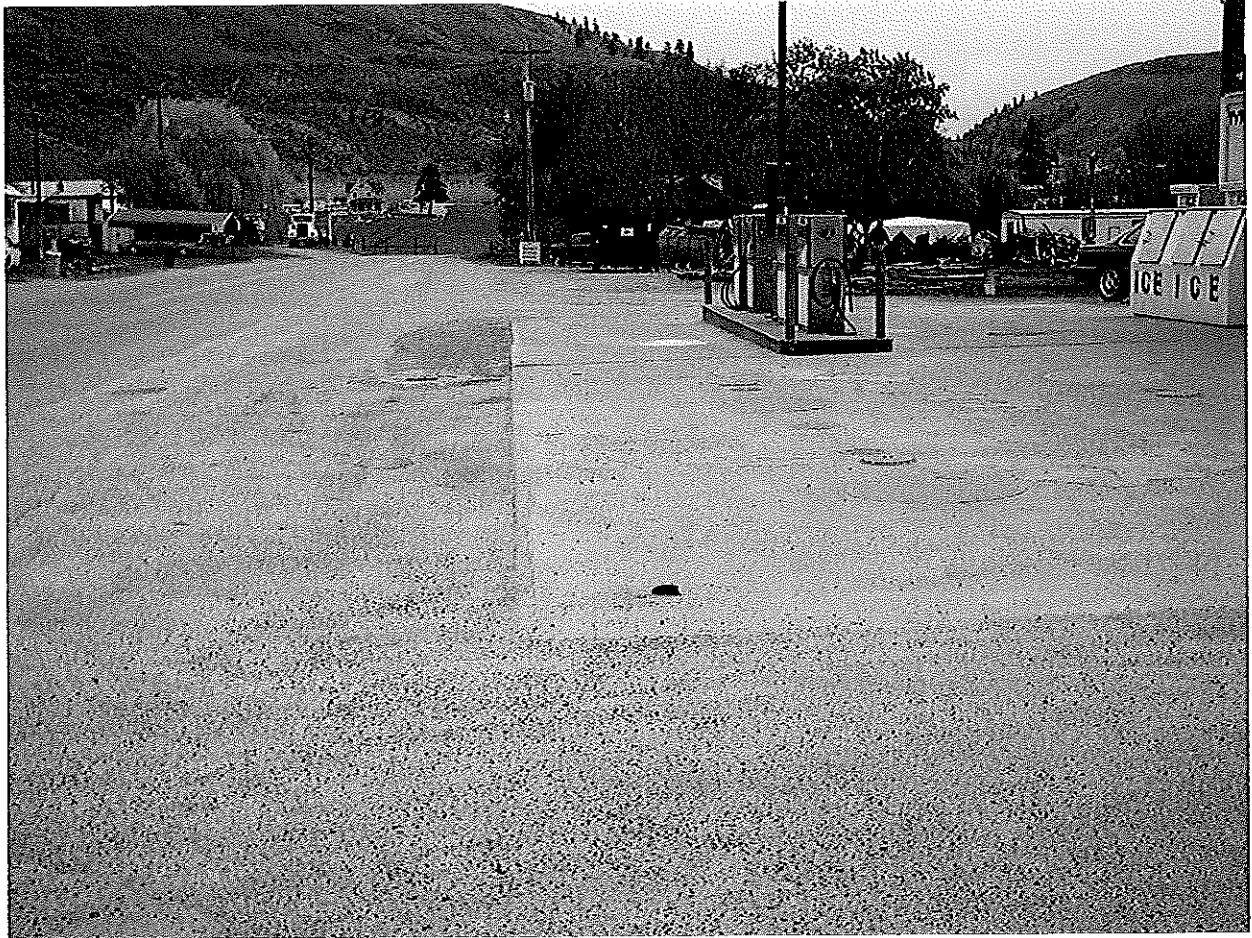
Figure 3 Looking east from the northwest corner of the property showing Palmer Ave on the left. The fuel tank fill pipes are shown in the concrete slab. This entire area, from the center of the street to the face of the building, is kept free of snow during the winter months to allow for access to the store and fuel pumps. The former fuel tanks were located under the concrete slab.

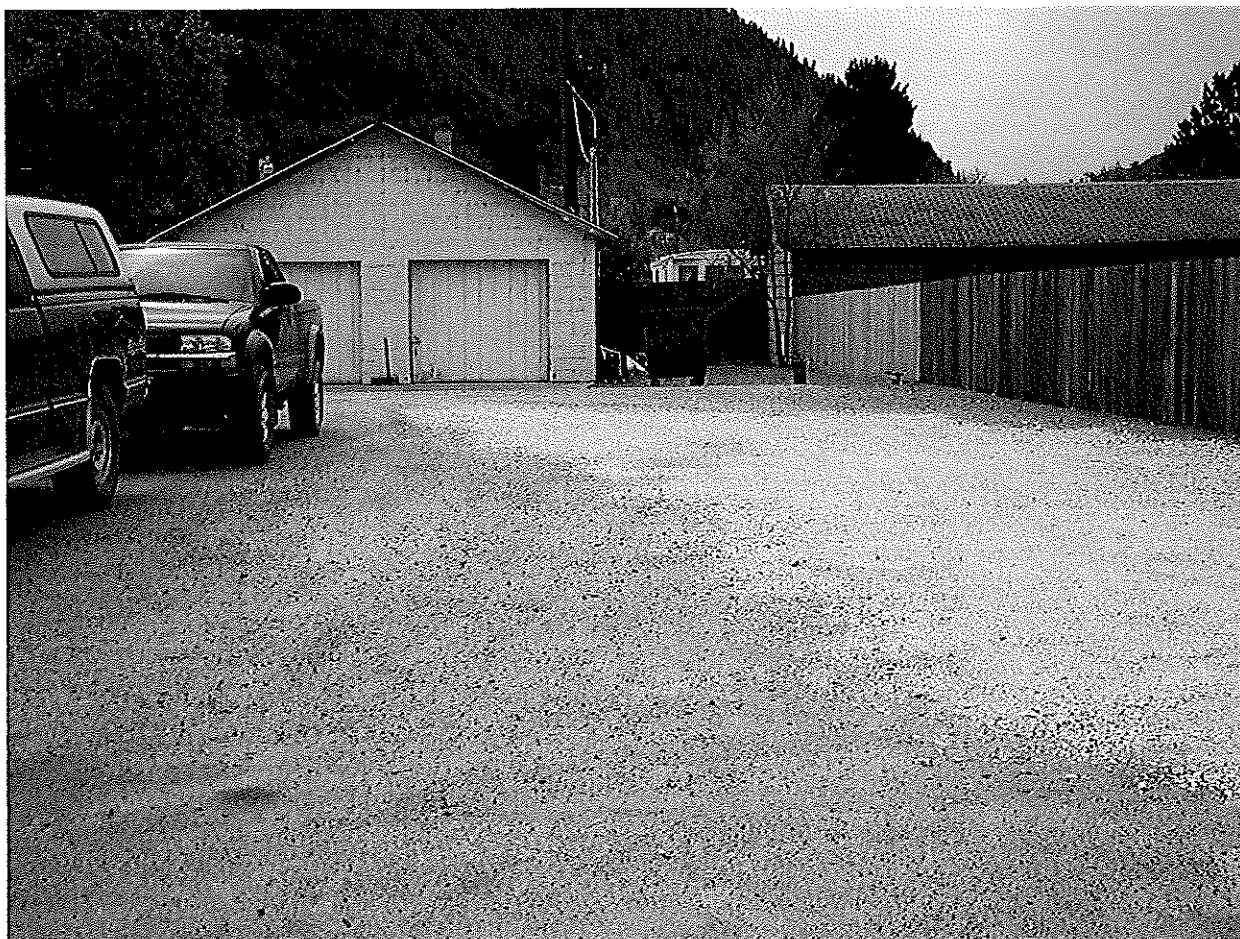
Figure 4 This photo is looking south and shows the west side of the property with a hard-packed, gravel surface. Snow is pushed to the back of the lot during the winter months and stockpiled to the right of the garage with access maintained on all sides of the store at all times to allow delivery vehicles to park behind the building while unloading. Drainage runs from the stockpiled area to the south and to the east away from the area where the fuel tanks were located.
